The Space Shuttle Columbia: A Materials Forensic Analysis

MICROSCOPY 2007

Steve McDanel
Failure Analysis and Materials Evaluation Branch
NASA
Kennedy Space Center, Florida

Shuttle Columbia: STS-107

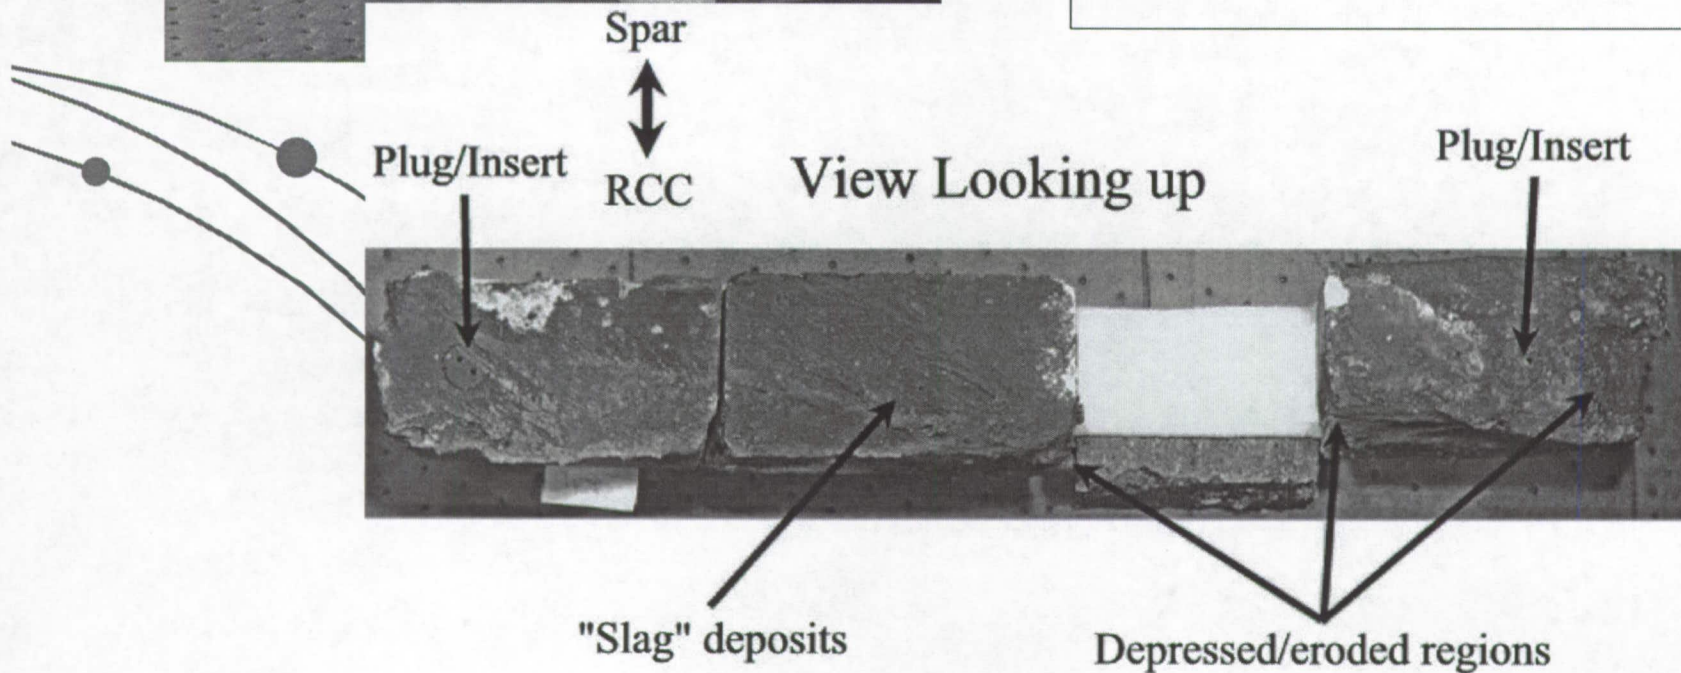
**Slumping and erosion patterns suggest plasma flow
out of leading edge cavity (consistent with vent)**

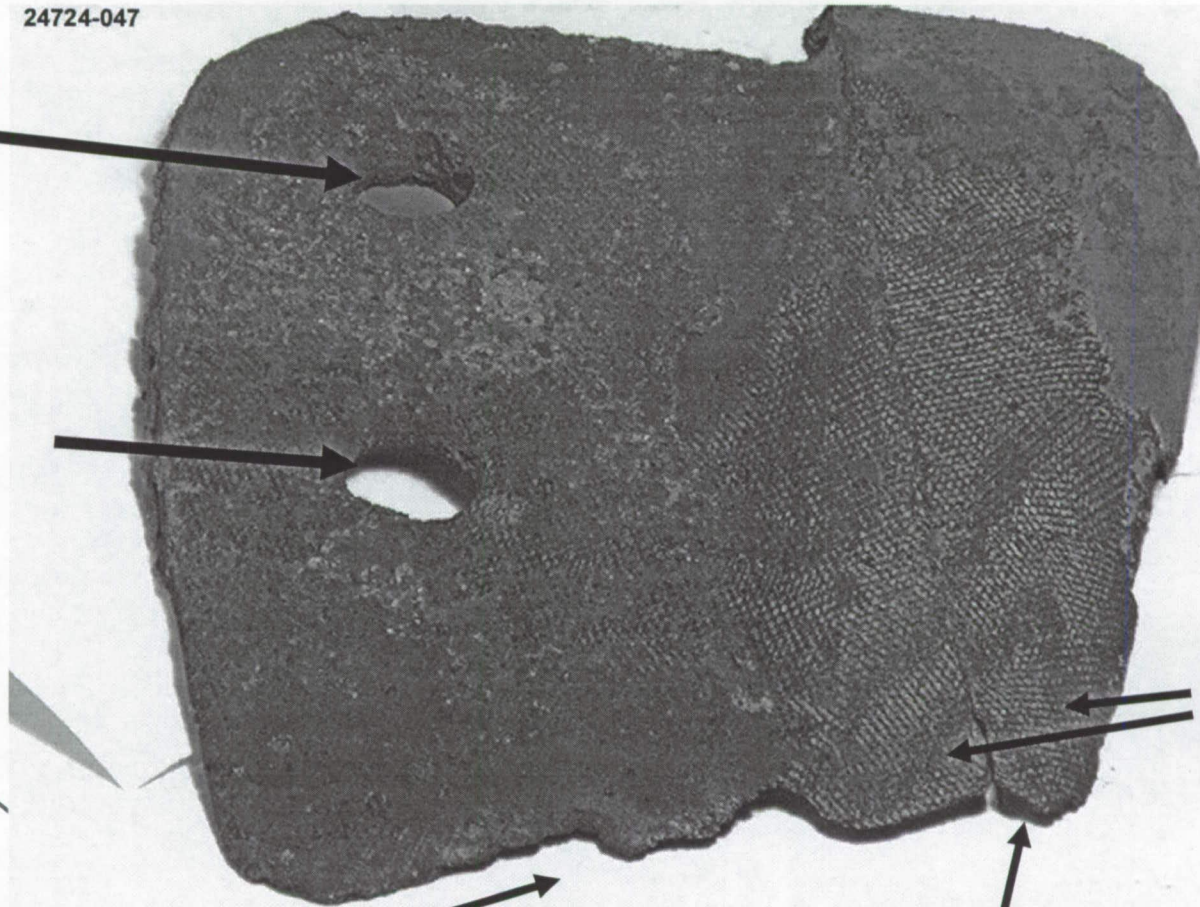
Erosion on Gap Surfaces of Panel 8 Outboard Lug & Matching Heel Piece

Heavy deposits in
holes

Inconel bushings
missing, yet
attach holes still
intact

Matching
eroded
plies

Lug fragment
tapers from .499" to
a min knife edge of
0.063"

Heel fragment tapers from .233" to
a min knife edge of 0.052"

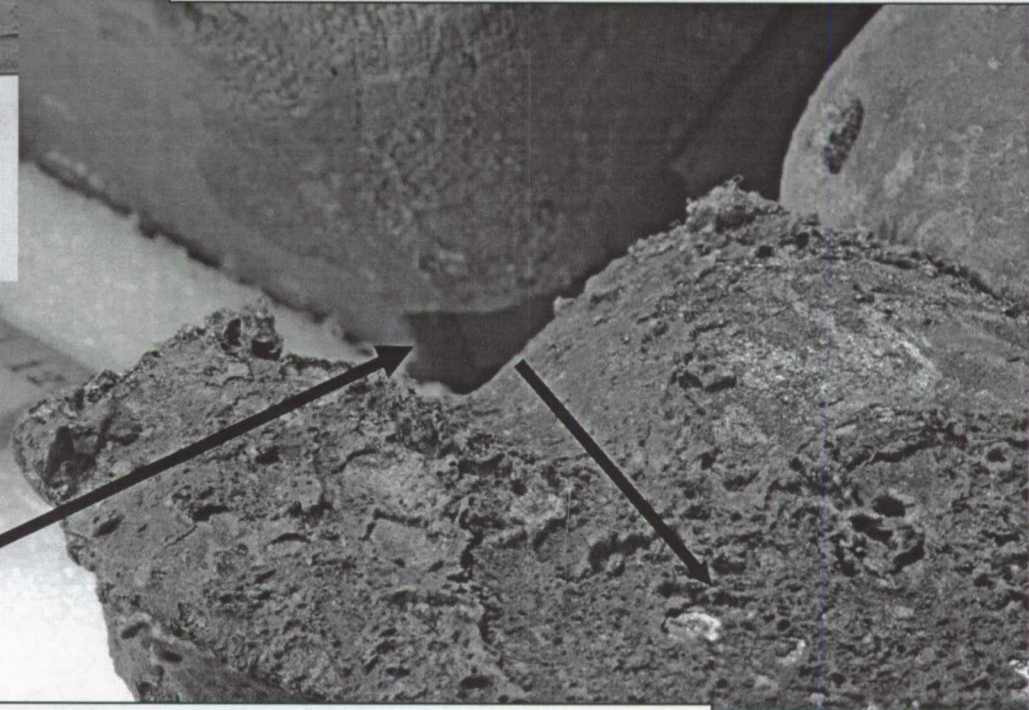
Slumping Source for Carrier Panel 9 Tile was Revealed

Slumping of C/P 9 Tile #1 Corresponds with Design Slot in Corner of RCC Panel 8

Slumping and erosion patterns suggest plasma flow across the carrier panel tile (from 8 toward 10)

Evidence of Hot Gas Flow Exiting Design Slot Indicates Significant Breach Was Into Panel 8

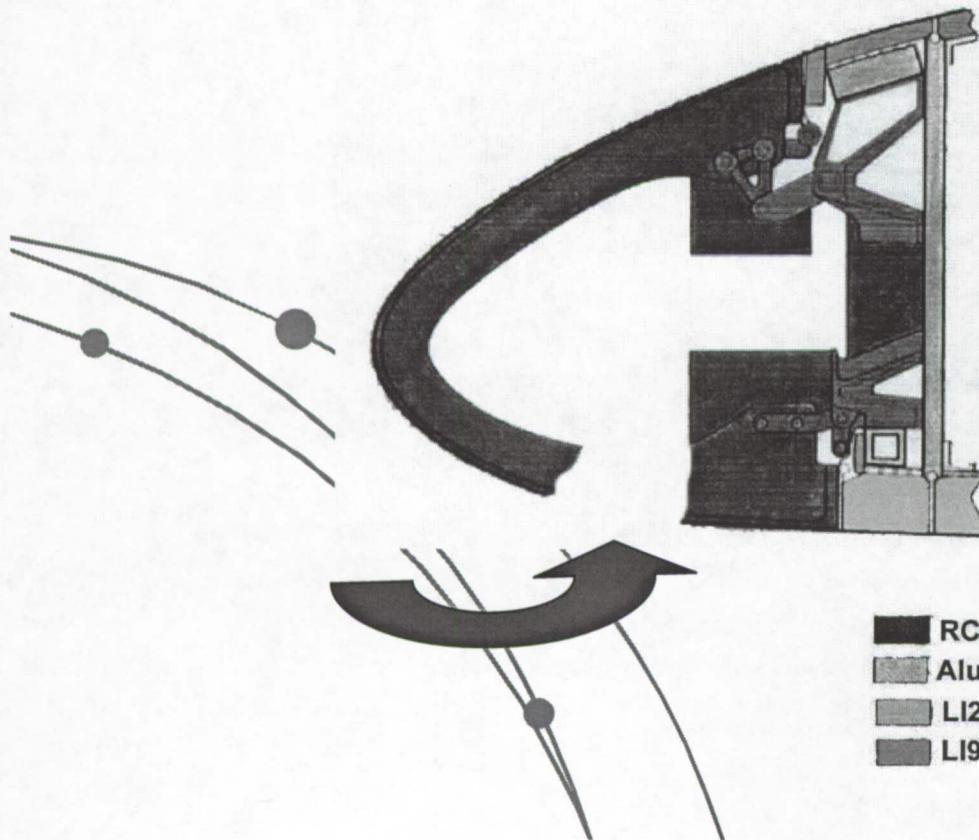
Debris Indicates Highest Probability Initiation Site

- Wing failure initiated in the panel 8 area
 - ♦ Most likely at the panel 8 area near 8-9 joint
 - ♦ Condition existed before or shortly after entry interface

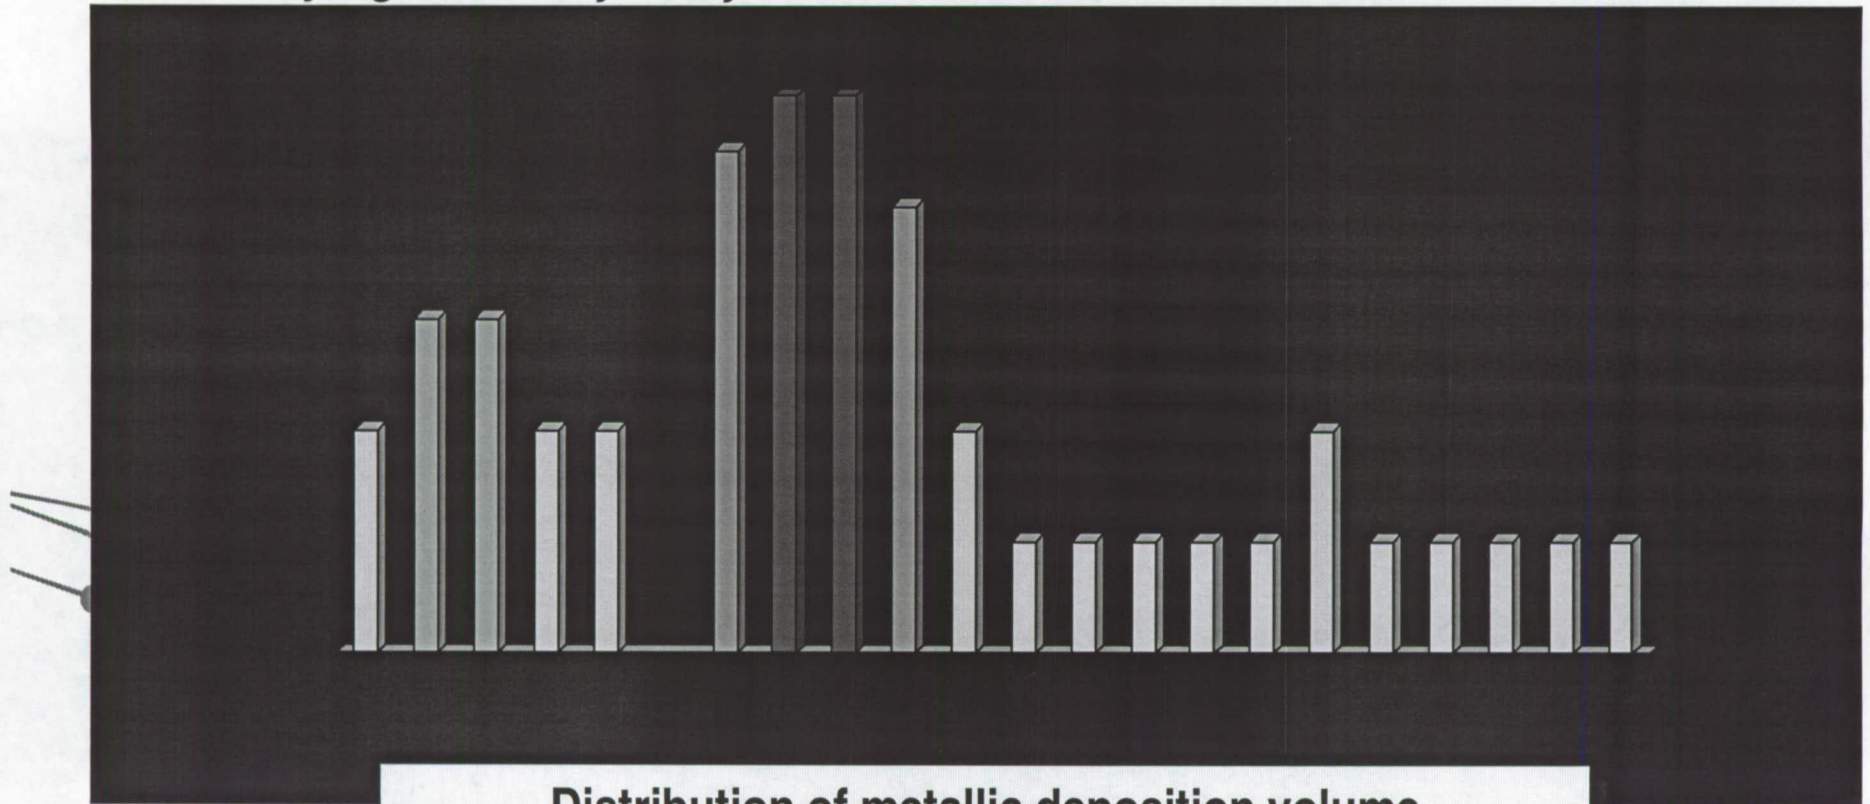
Relative Metallic Deposition on L/H Wing Materials

**Distribution of metallic deposition volume
was centered around panels 8 & 9**

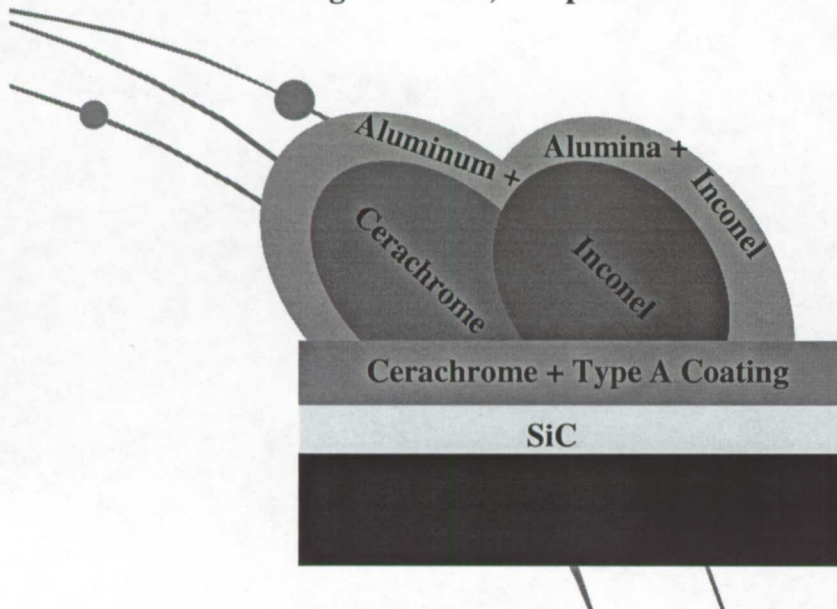
Slag Item 2200, Sample 6A1

LH RCC #8 - Slag Feature 2

Thick Globules

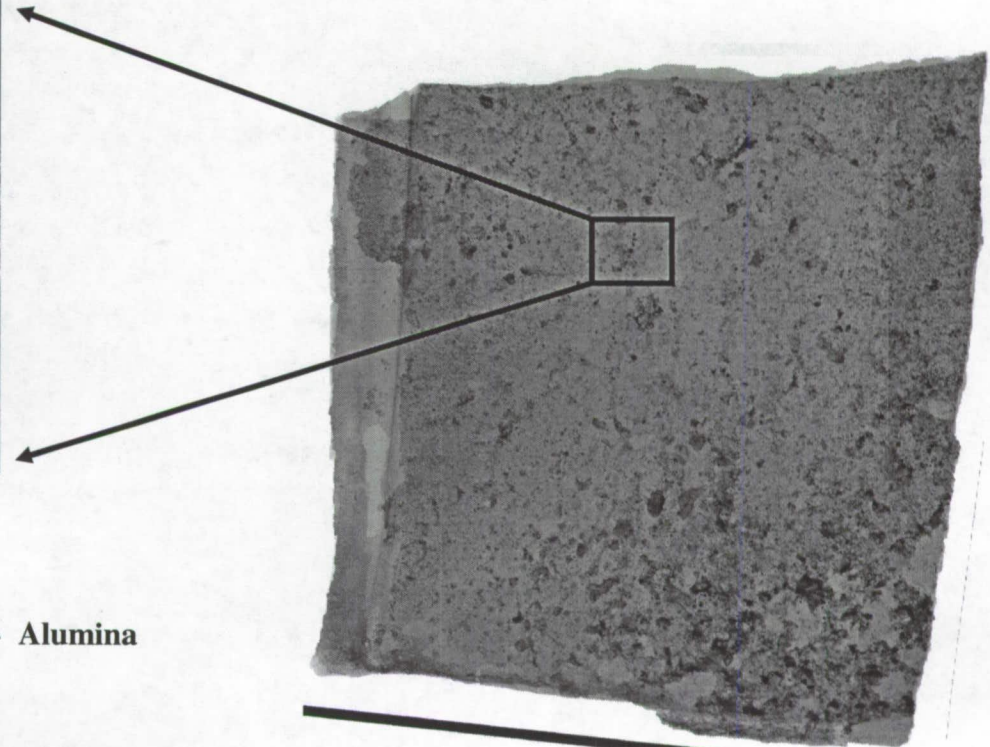
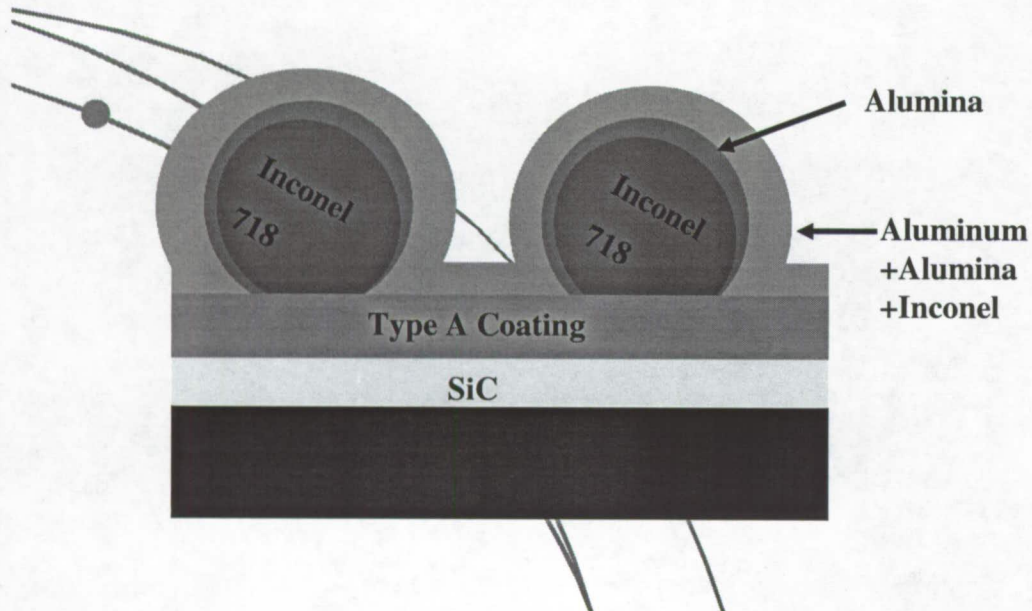
Slag Item 2200, Sample 6C1

LH RCC #8 - Slag Feature 3 Spheroids

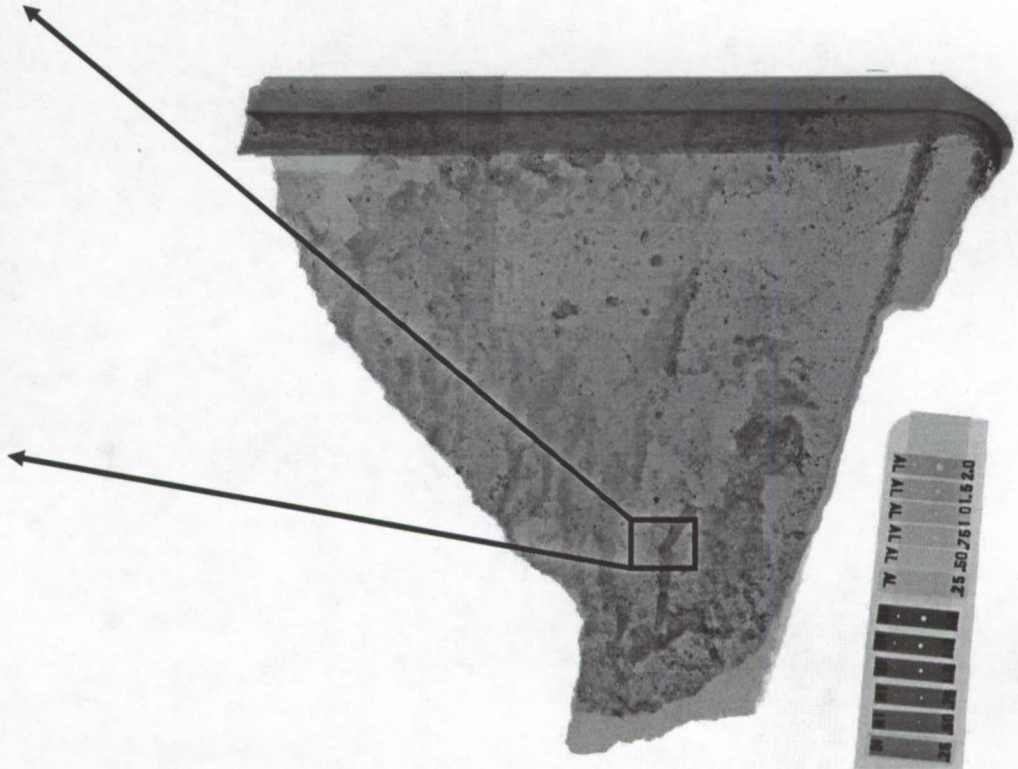
Slag Item 43709, Sample 2A1

LH RCC #8 - Slag Feature 1

Tubular Shaped

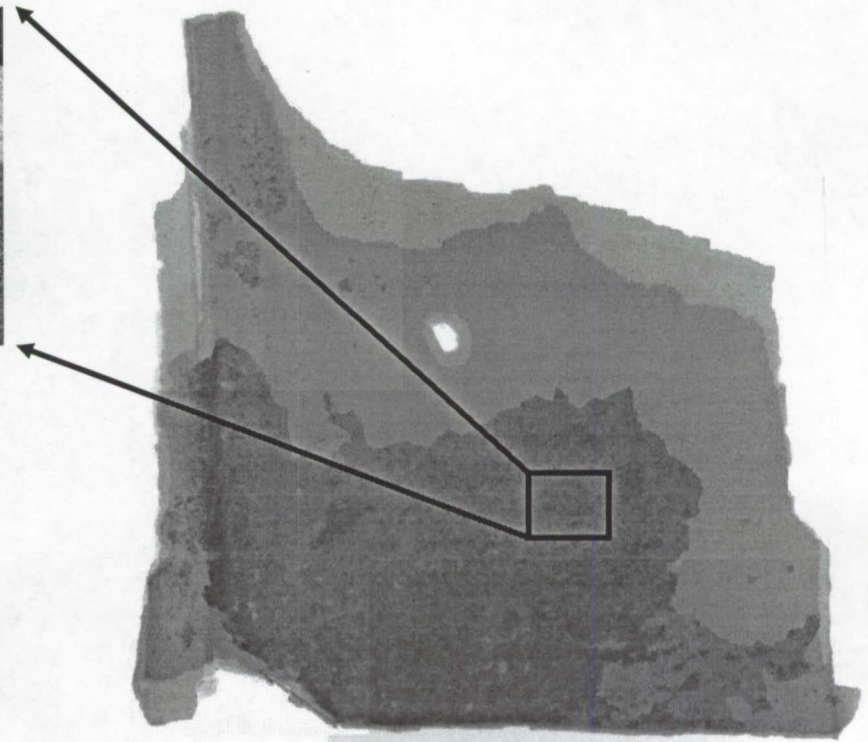
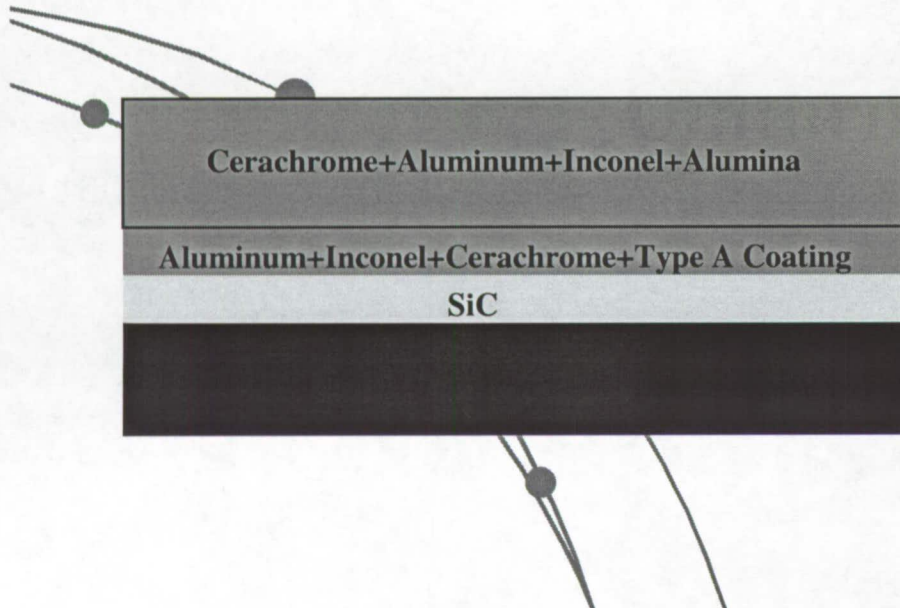
Slag Item 16523, Sample 4A1

RH RCC #8 - Slag Feature 4 Uniform Deposit

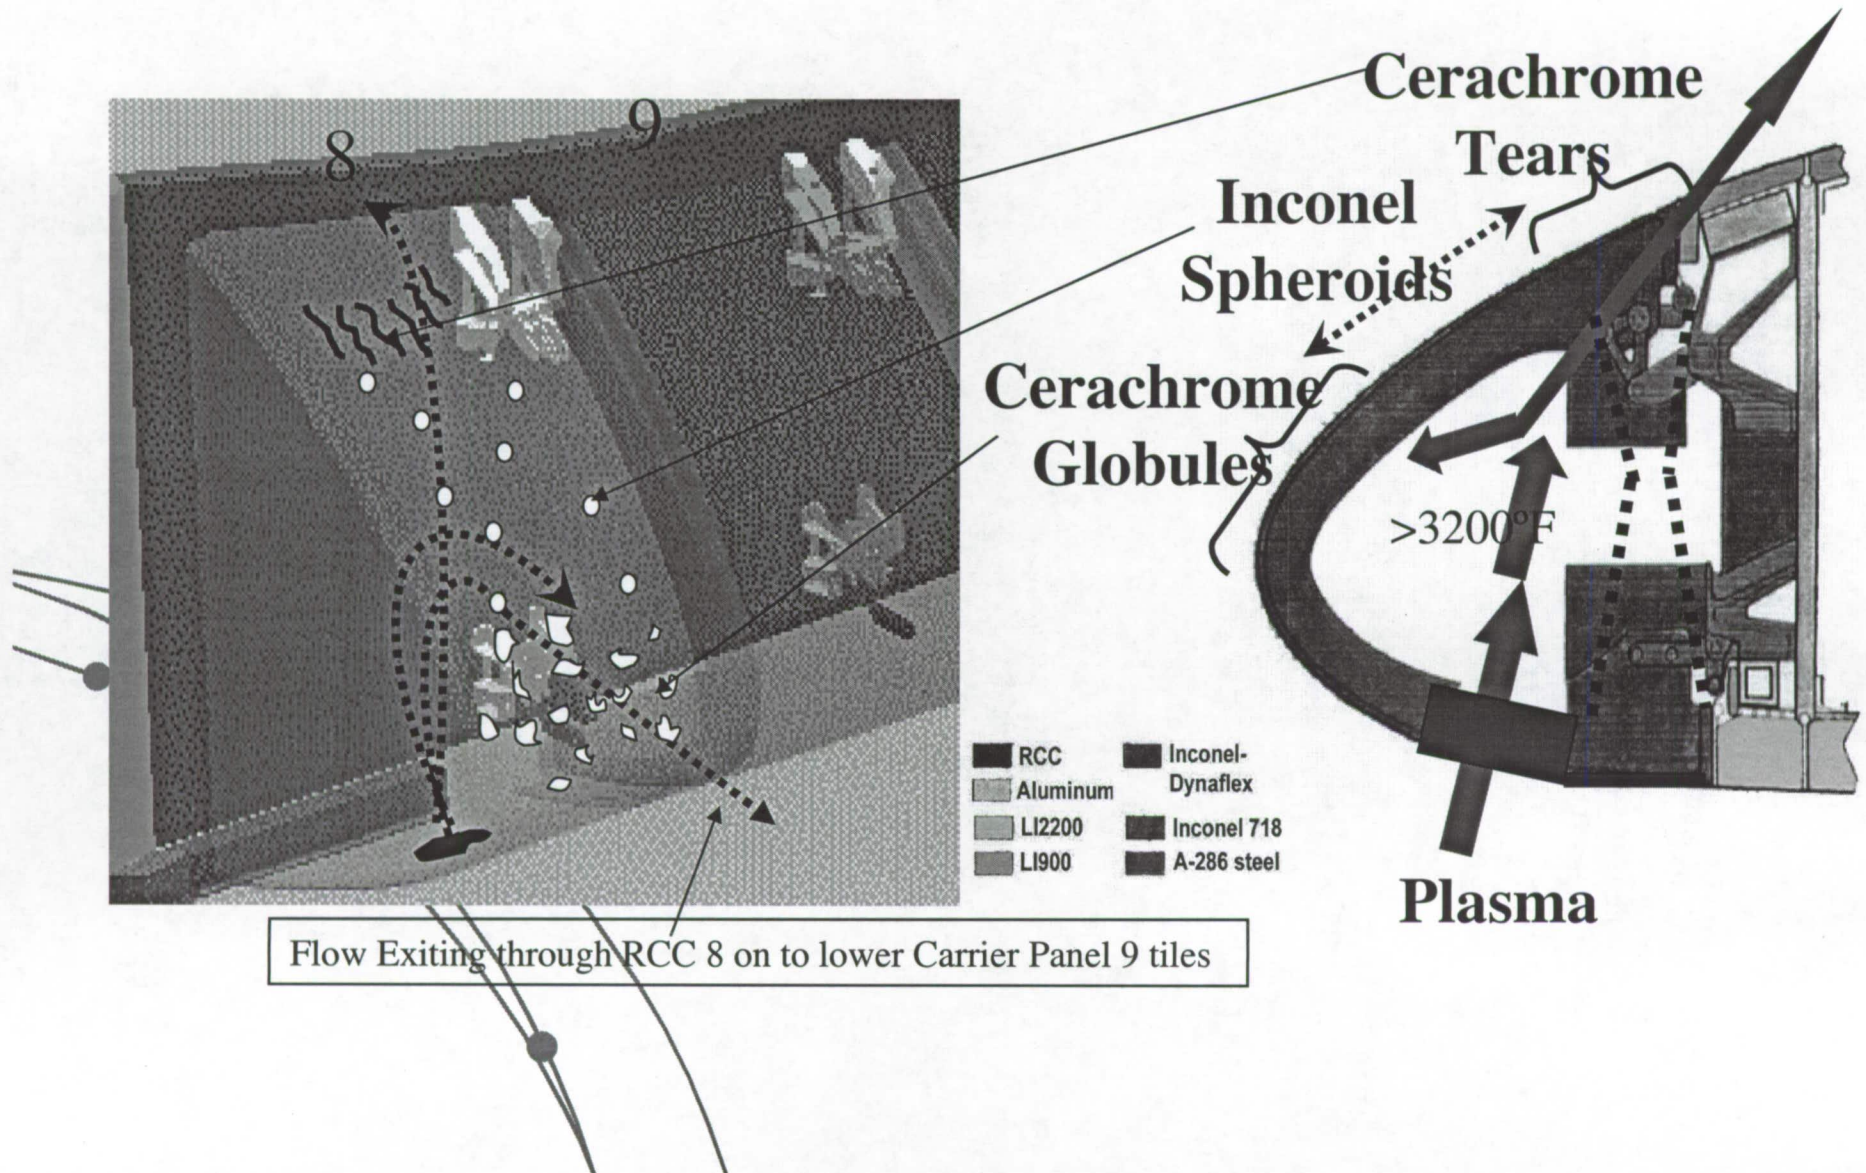
Proposed Breach Location & Plasma Flow Based On Slag Results

- Large amounts of melted ceramic cerachrome insulator
 - **High temperature >3200°F**
- No indication of stainless steel spar fittings (A286) in deposit
 - **Breach location away from spar fittings**
- Cerachrome + Inconel in first deposited layers
 - **Melting of spanner/foil/fittings + Insulator**
- Aluminum deposition secondary event

Deposit layering suggests plasma impingement location

Deposit distribution & shape suggests plasma flow direction and deposition duration
